ALERT SERVICE BULLETIN

Checking of the cylinder head assy. (2/3) for ROTAX® Engine Type 912 and 914 (Series)

This ASB revises ASB-912-062/ASB-914-044 Initial issue

ATA System: 72-30-00 cylinder head

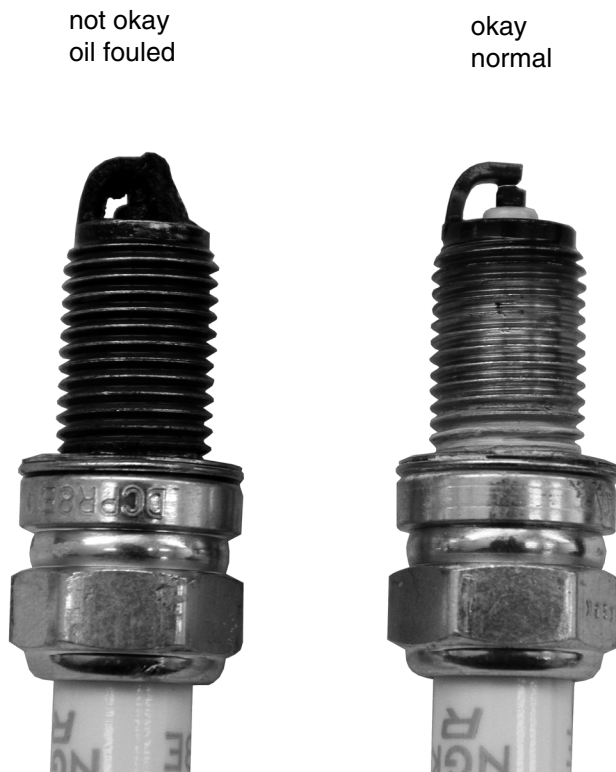
*Fig. 1
spark plug*

Due to a deviation in the manufacturing process some cylinder heads may have an oil leak in the intake channel in the area of the valve guide. There is a possibility of small machined through holes, which can increase the oil consumption which may result in an engine stoppage.

NOTE: Unusual deposits (excessive carbon or oil) on the spark plugs are an indication of a defective cylinder head which must be replaced. Figure 1 shows comparison between a used spark plug in normal condition and one that is not.

Affected spark plugs with such deposits shown in chapter 4 Fig. 1, have to be removed and can not be reinstalled.

If excessive deposits (oil or carbon) are found on the spark plugs the cylinder head must be replaced in accordance with the relevant Maintenance Manual (Heavy) and any relevant aircraft manufacturer instructions.
